UNDERWATER BRIDGE INSPECTION REPORT

STRUCTURE NO. 6665

ISLAND LAKE

JOB NO. 5221 (CEI 4)

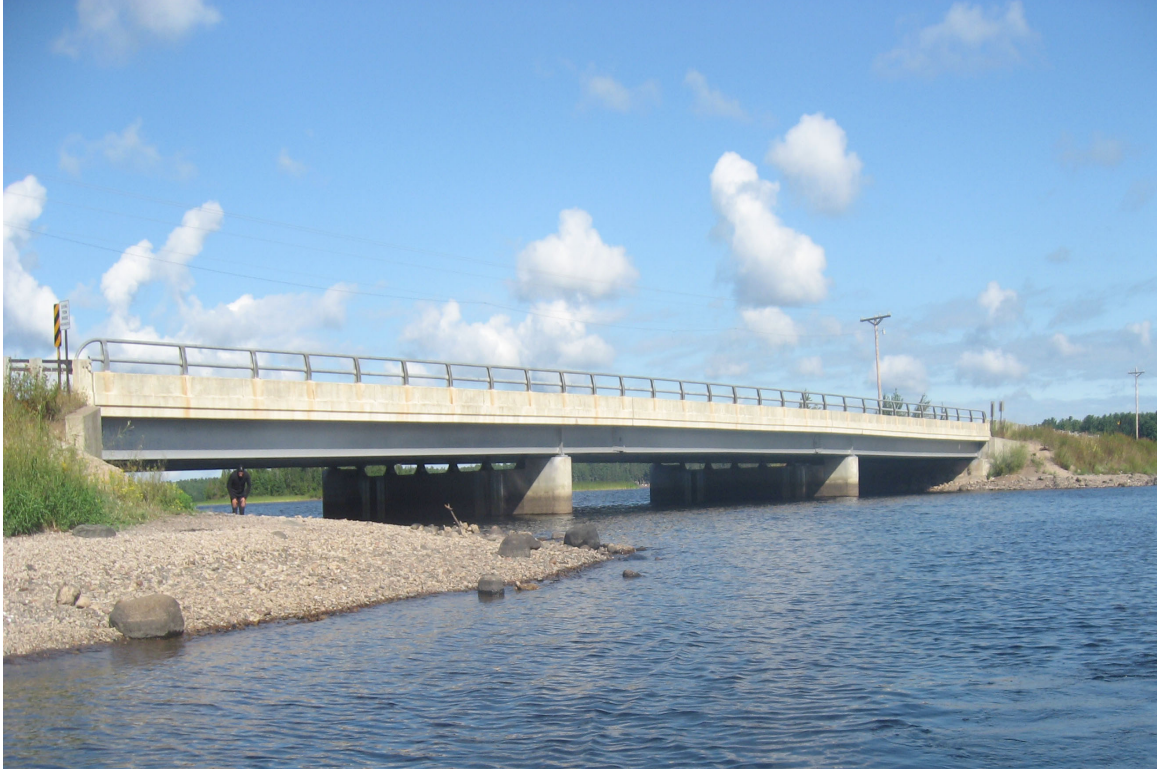
Photograph 1. Overall View of Structure, Looking Northwest.

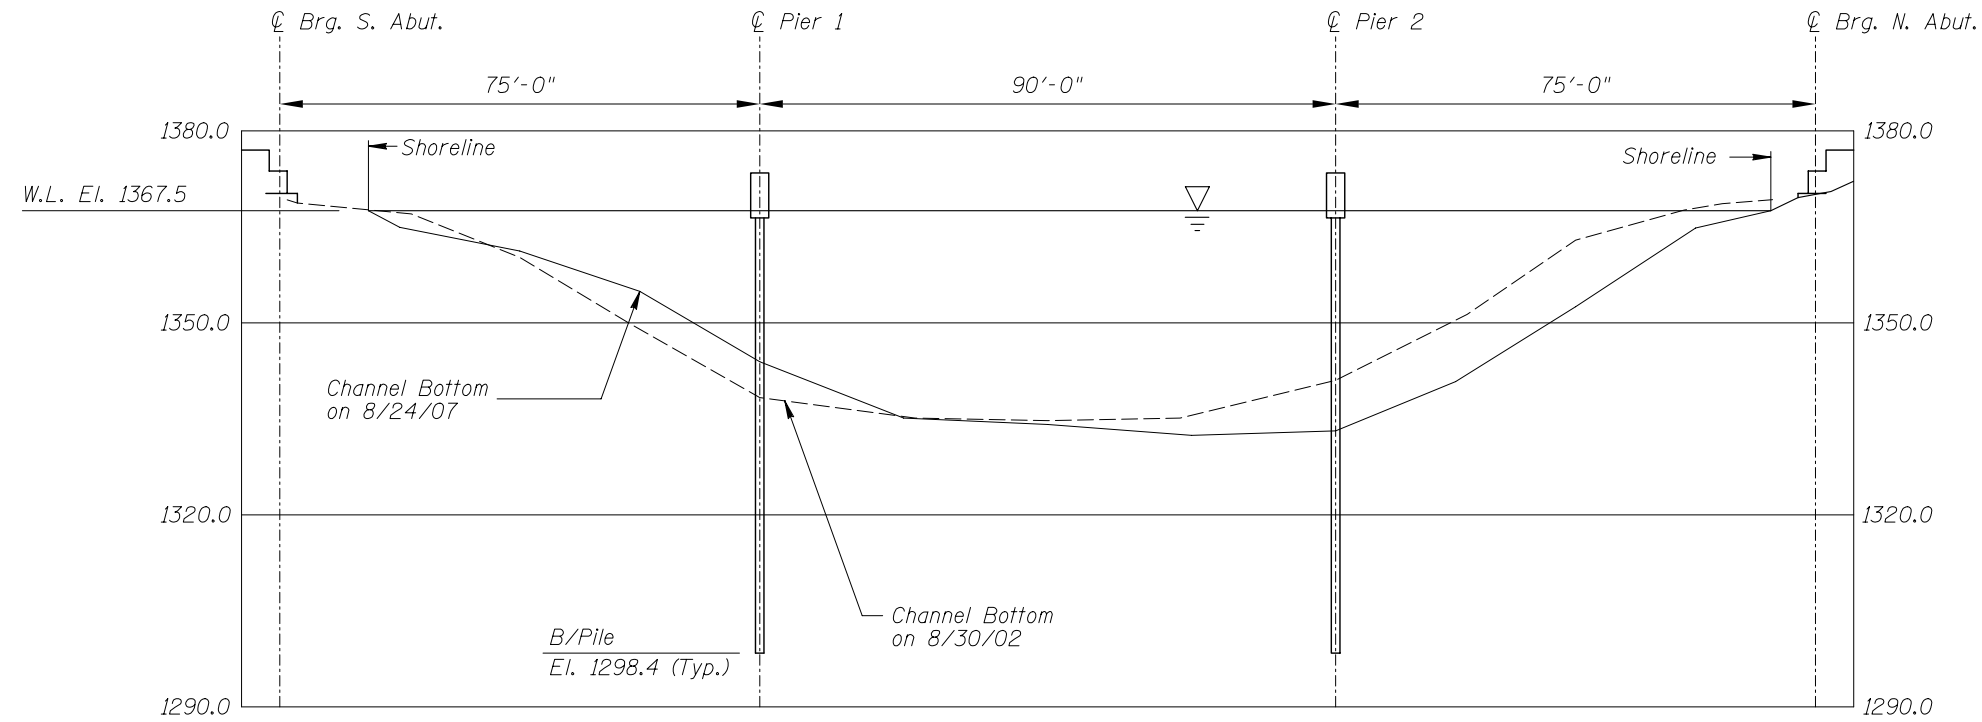
EAST FASCIA PROFILE

- 4 Cracking between new and old concrete along entire interface, typically hairline to 1/8 inch wide with 1/2 inch maximum width (at south side of Pier 2).

- 5 Rust nodules and surface corrosion were observed on all of the steel columns along the entire length, with the heaviest concentration (up to 1.5 inch diameter and/or uniform coverage) exhibited on the lower half, with 75 to 100 percent of the surface area covered and section losses up to 1/16 inch deep. On the upper half, lesser concentrations of up to 1 inch diameter nodules, with up to 50 percent of the surface area covered and section losses up to 1/8 inch deep.

- 7 Steel shell piles under pier widening additions exhibited surface corrosion ranging in coverage from 25 to 50 percent on upper 20 to 25 feet, and 80 to 100 percent with rust nodules on the bottommost 6 to 10 feet. Nodules typically have up to 1/32 inch deep pitting and a maximum of 1/16 inch deep pitting on the upper 10 feet of the piles.

Monitor cracking between the original and new concrete of piers, and if found to be worsening, repairs with epoxy based materials may be required. The cracking appears stable (same as last inspection, no differential movement), but could be aggravated by freeze/thaw action, and should therefore be monitored during future inspections.
